# Analysis of Overloading Impact on Harmonic Content and Loss of Life in Distribution Transformers

This research was conducted on a distribution transformer coded PGCE, located on Jalan Lemah Abang Raya, Kampung Rawa Lintah, Mekarmukti, North Cikarang District, Bekasi Regency, West Java 17530, Indonesia. The study was carried out over a period of three months, from March to May 2022. The selected transformer was identified as experiencing a high loading condition, making it suitable for evaluating the impact of overloading on transformer performance and service life.

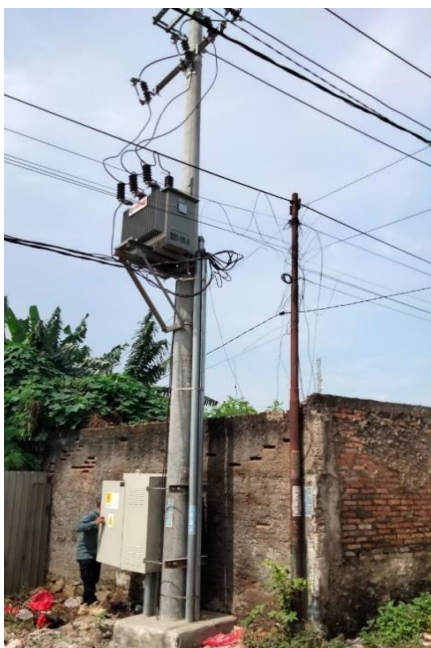
Figure 1. Distribution Transformer coded PGCE

Figure 1 shows the PGCE distribution transformer, which served as the object of this study. The transformer is a pole-mounted distribution transformer supplying electrical power to residential and commercial consumers in the Lemah Abang service area. Based on preliminary field observations and operational records from PT PLN (Persero), the transformer had experienced a sustained overload condition, making it an appropriate case study for evaluating the effects of excessive loading on transformer performance. Therefore, this transformer was selected to investigate the impact of overloading on transformer loading, voltage drop, and transformer loss of life, as well as to assess the effectiveness of

Based on these results, the loading percentage of the distribution transformer is significantly above the maximum allowable limit of 80% as regulated by SPLN No. 17 of 2014. If left unaddressed, this condition causes excessive heat, which leads to a decrease in power quality and eventual damage to the electrical distribution system.

To address the overload condition on the PGCE transformer, PT. PLN (Persero) ULP Lemah Abang implemented a technical intervention by installing an insertion transformer (SNTR) and performing load splitting. This process involved moving a portion of the load from the PGCE transformer to a newly installed transformer to ensure both operate within safe loading limits.

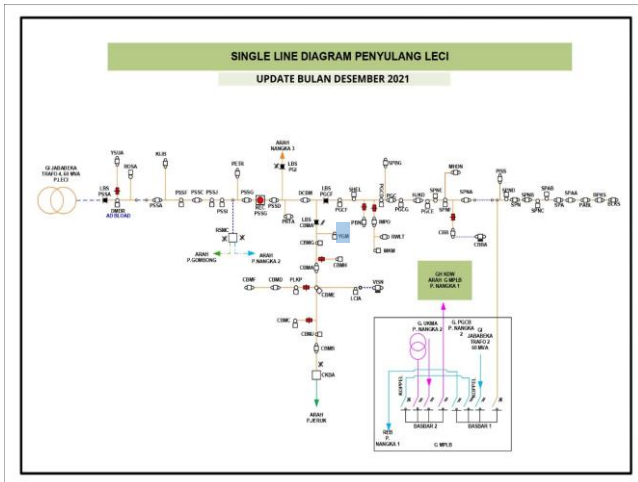
Figure 3. Single Line Diagram Before Improvement

One of the substations in the low-voltage network of the Leci Feeder experienced a problem in the form of an excessive load or overload. The substation experiencing this overload is the PGCE distribution transformer.

Calculations revealed that the voltage drop reached up to 17%. According to SPLN series 1 of 1995, the service voltage variation is set at a maximum of +5% and a minimum of -10% [3]. Thus, the PGCE transformer not only experienced an

overload but also a voltage drop that significantly exceeded the standard.

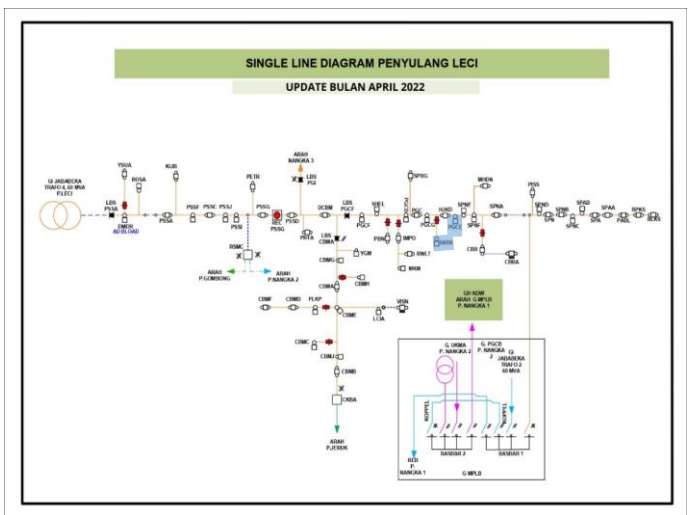
Figure 5. Single Line Diagram After Improvement

To overcome these operational problems, PT PLN (Persero) implemented a load-splitting strategy by installing the SNTR insertion transformer, as illustrated in Figure 5. The additional transformer redistributed part of the electrical load from the PGCE transformer, thereby reducing the loading on the original transformer and balancing the feeder load. This technical intervention represents a practical solution for improving transformer operating conditions without replacing the existing transformer.
